Manhole Inspection Summary

Manhole # S45K2_007MH

Insp Date: 1/11/08 1:50 PM

Location Address: **4814 Fairhaven Pennington**

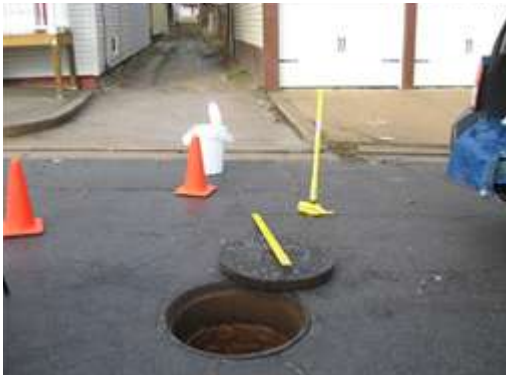
Location View

Cherry Ave & Pennington-Fairhaven alley

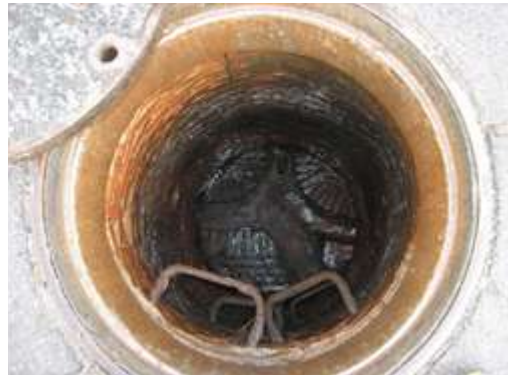
Top View

steps

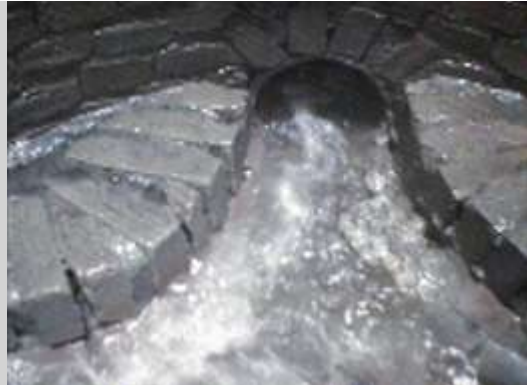
12 O'Clock Outflow

8 in. Circular Gravity Sewer
Pipe Out @ 12 O'Clock

Pipe Height: **9.6** (in.) Rod and Bar (Angled)
Pipe Material: **Clay** ☐ Pipe Lined
Invert Depth: **12.07** (ft.) Flow Characteristics: **Fast**
Deposits: ☒ None ☐ Mud ☐ Sludge ☐ Debris ☐ Grease
Silt Depth: (in.) Deposits Extent:
Infiltration: **None** Pipe Seal Cond: **Sound**

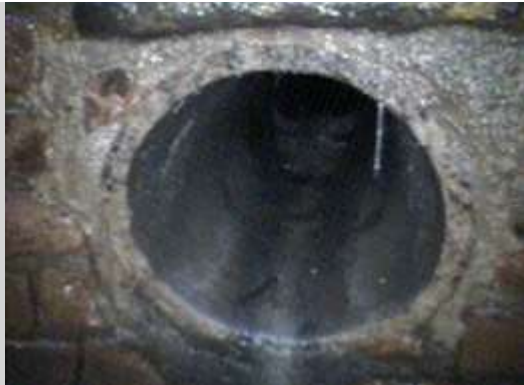
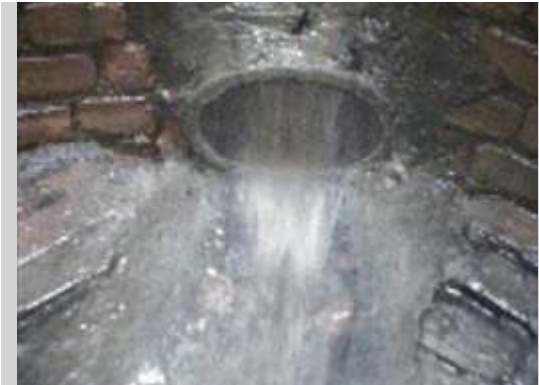
5 O'Clock Inflow

Pipe In @ 5 O'Clock

Pipe Height: **8.4** (in.) Rod and Bar (Angled)

Drop: Inside	Rod and Bar
Angled: Yes	Reading: 10.44 (ft.)
	Inv Depth: 11.44 (ft.)
Drop Condition: Open

Drop: Inside	Rod and Bar
Angled: Yes	Reading: 11.01 (ft.)
	Inv Depth: 12.01 (ft.)
Drop Condition: Partly Clogged
